Effectiveness of Electrical Fish Barriers Associated with the Central Arizona Project

ROBERT W. CLARKSON*

U.S. Bureau of Reclamation, Phoenix Area Office, Post Office Box 81169,
Phoenix, Arizona 85069-1169, USA

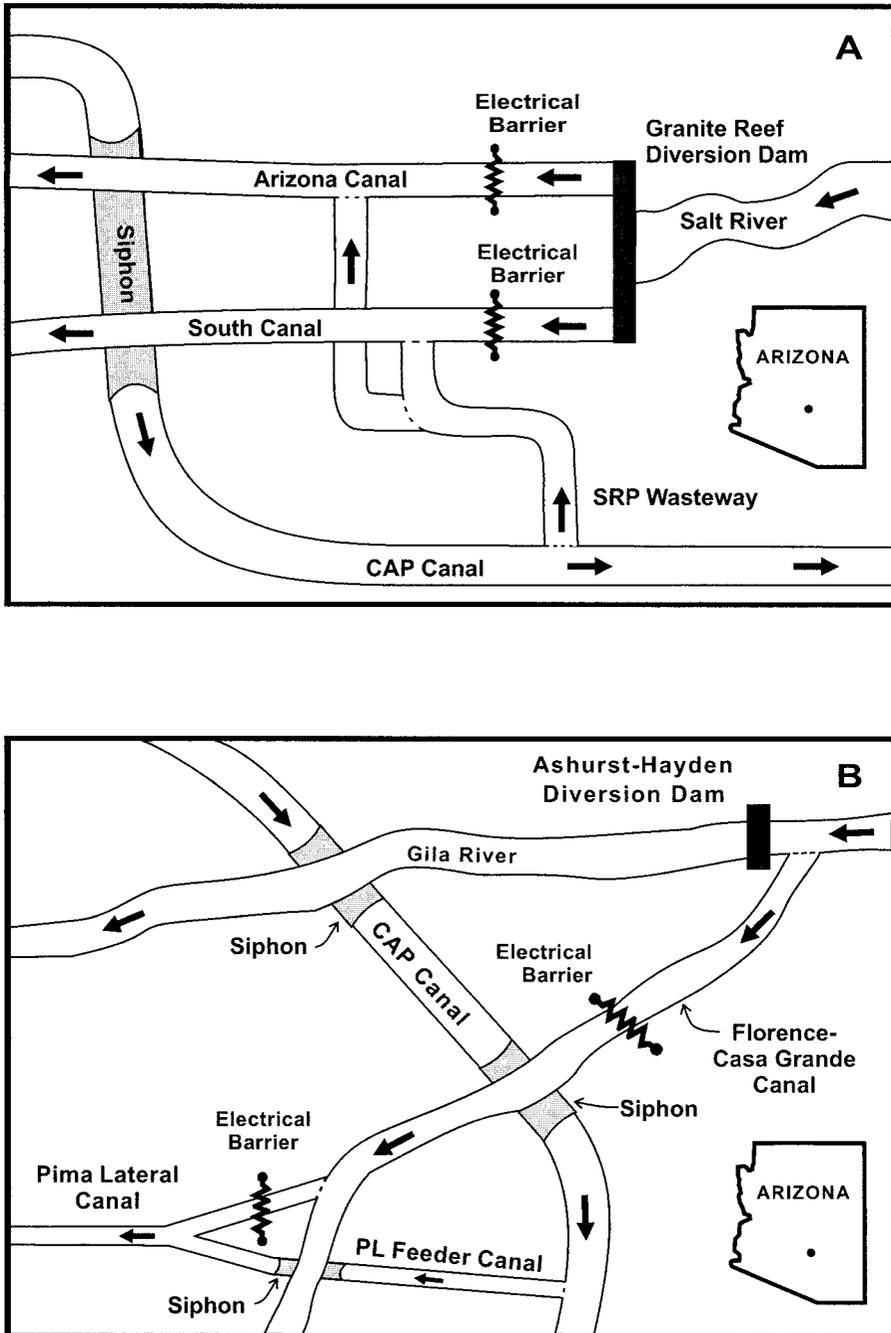
FIGURE 1.—Diagrams of the interconnections between the Central Arizona Project (CAP) and the (A) Salt River Project and (B) San Carlos Irrigation Project canals, showing relationships with surface waters and locations of electrical fish barriers; PL denotes Pima Lateral.

Electrical barriers were constructed in 1988 on two Salt River Project canals (Figure 1a). The barriers were intended to prevent fish movements from the CAP into the Salt and Verde river systems upstream. At the electrical barrier sites, the Arizona Canal is 18.5 m wide, and the South Canal is 15.8 m wide. The maximum depth in both canals is approximately 2.5 m in these areas. Both are concrete lined and steep sided. Recent annual flow volumes over the electrical barriers were near 7.24

Another electrical barrier was installed in 1990 on the San Carlos Irrigation Project Pima Lateral Canal (Figure 1b). This barrier was to prevent CAP fishes from entering the Florence-Casa Grande Canal and moving upstream to the Gila River, the San Pedro River, and Aravaipa Creek (which is inhabited by federally threatened native fishes). The concrete-lined Pima Lateral Canal is 24.5 km downstream from the Florence-Casa Grande Canal diversion on the Gila River, and transports approximately $1.65 \times 10^8 \text{ m}^3$ (134,000 acre-ft) per annum at a maximum rate of $18.7 \text{ m}^3/\text{s}$ ($660 \text{ ft}^3/\text{s}$). Soon after the electrical barrier on the Pima Lateral Canal was constructed, additional inter-

connects between the CAP and the Florence-Casa Grande Canal were built, rendering the barrier ineffective. Thus another barrier was placed in 1990 on the Florence-Casa Grande Canal 4.2 km downstream from the Gila River (Figure 1b). The Florence-Casa Grande Canal is unlined and carries approximately $3.79 \times 10^8 \text{ m}^3$ (307,000 acre-ft) per annum at a maximum rate of $35.8 \text{ m}^3/\text{s}$ ($1,265 \text{ ft}^3/\text{s}$). Canal dimensions vary from 15 to 30 m wide, with an average depth of 1 m. As the barrier on the Pima Lateral Canal was considered redundant, operations ceased in 1992.
